Nat RE Proj

Photo No 117

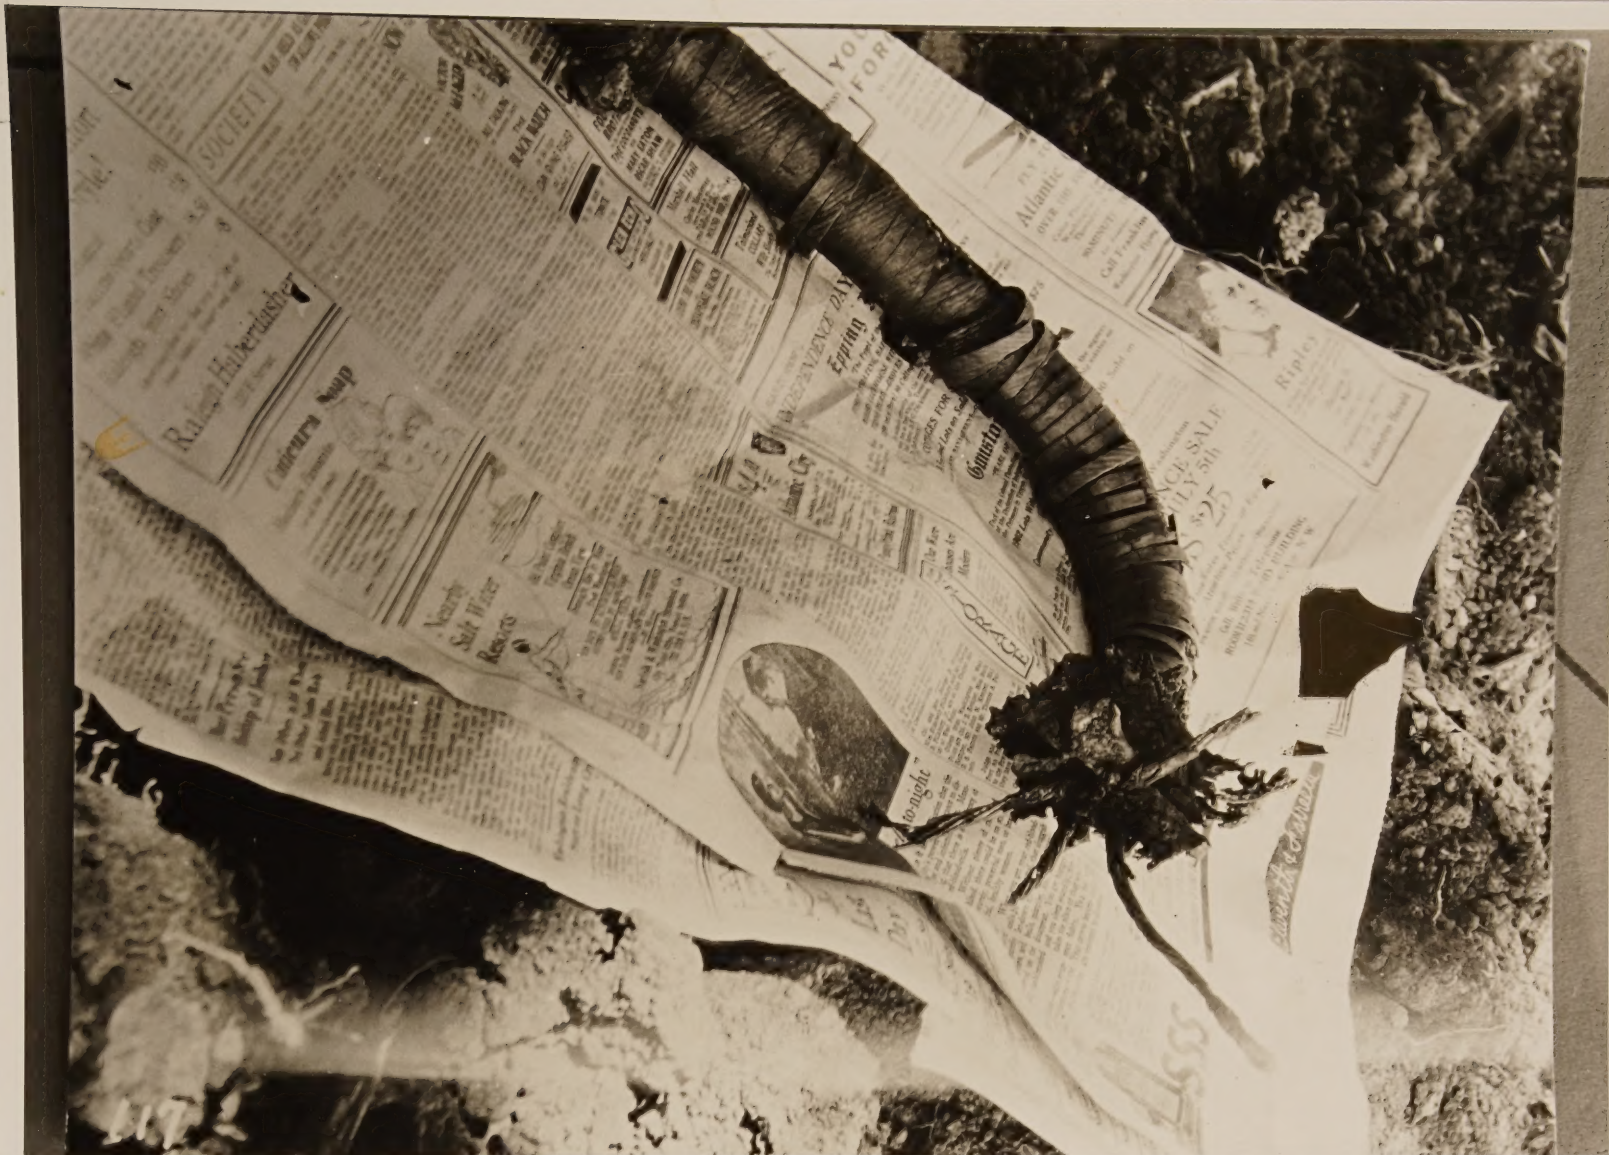
Jones showing burned end of cable  
on Jones farm - damaged done by  
lightning.

Fault located within one foot with  
detector (coil & headphones with interrupter  
and high voltage
